Stepwise mitigation of the Macesnik landslide, N Slovenia

M. Mikoš¹, R. Fazarinc², B. Pulko¹, A. Petkovšek¹, and B. Majes¹

Abstract. The paper gives an overview of the history of evolution and mitigation of the Macesnik landslide in N Slovenia. It was triggered in 1989 above the Solčava village, but it enlarged with time. In 2005, the landslide has been threatening a few residential and farm houses, as well as the panoramic road, and it is only 1000 m away from the Savinja River and the village of Solčava. It is 2500 m long and up to more than 100 m wide with an estimated volume in excess of 2 million m³. Its depth is not constant: on average it is 10 to 15 m deep, but in the area of the toe, which is retained by a rock outcrop, it reaches the depth of 30 m. The unstable mass consists of water-saturated highly-weathered carboniferous formations. The presently active landslide lies within the fossil landslide which is up to 350 m wide and 50 m deep with the total volume estimated at 8 to 10 million m³. Since 2000, the landslide has been investigated by 36 boreholes, and 28 of them were equipped with inclinometer casings, which also serve as piezometers. Surface movements have been

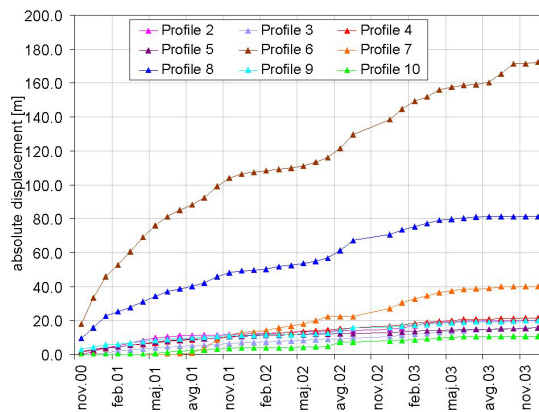
**Fig. 5.** Absolute displacements in measuring cross sections on the Macesnik landslide (see Fig. 3 for the position of cross sections).

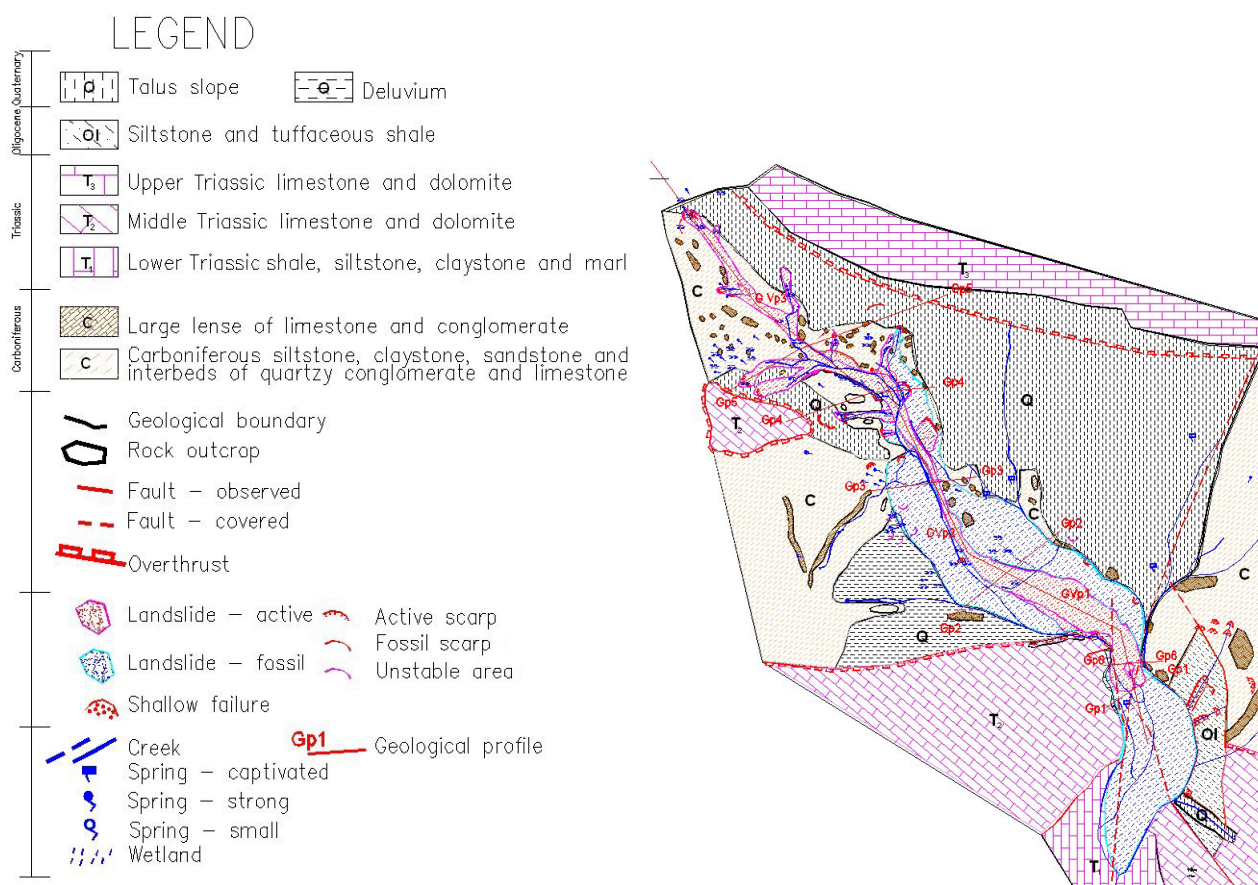
Fig. 6. Engineering geological map of the Macesnik landslide with a legend (modified from Vlaj and Žigman, 2001).

Data from the drilling cores show that the sliding mass was heterogeneous, mainly dark-grey stiff clay with layers of more permeable clayey gravels of different thicknesses at different depths. This interpretation was supported by the local engineering geologic map. In the investigated area, the following rock types were determined (Fig. 6):

1. Carboniferous siltstone, claystone, and sandstone with lenses and interbeds of quartzite conglomerate and limestone (“C”).
2. Lower Triassic shale, siltstone, claystone and mud (“T₁”); Middle Triassic (“T₂”) and Upper Triassic limestone and dolomite (“T₃”).
3. Oligocene siltstone and tuffaceous shale (“O1”).
4. Quaternary talus slope and deluvium (“Q”).

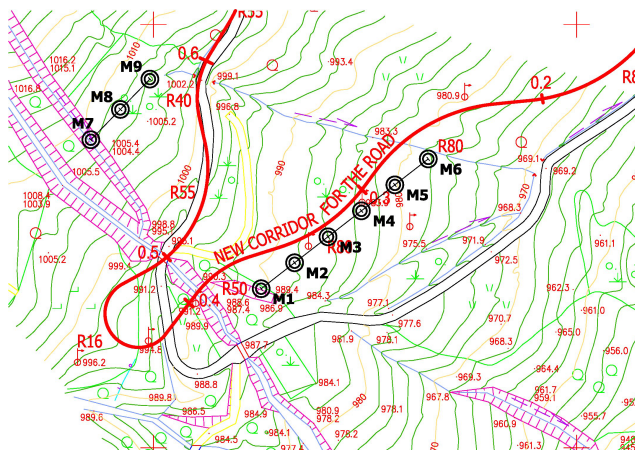
Fig. 8. Ground map of the middle part of the Macesnik landslide with a new corridor for the panoramic road and the proposed wells in two lines (M1–M6 & M7–M9).

1. Upper part of the landslide with the area above and around the pontoon bridge (Fig. 7);
2. Middle part of the landslide around the road crossing with the panoramic road (Fig. 8);
3. Lower part of the landslide around and above the rock outcrop that temporarily stopped further landslide advancement (Fig. 9).

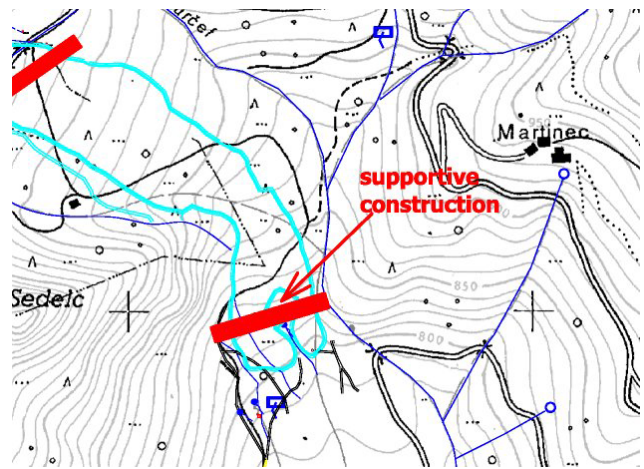
Fig. 9. The proposed location of a supportive construction around the rock outcrop at the toe of the Macesnik landslide.

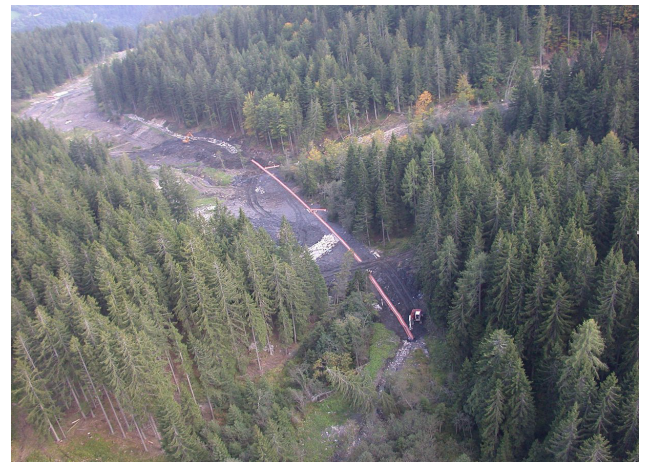
Fig. 10. Executed peripheral surface drainage at the western landslide edge above the prefabricated bridge.

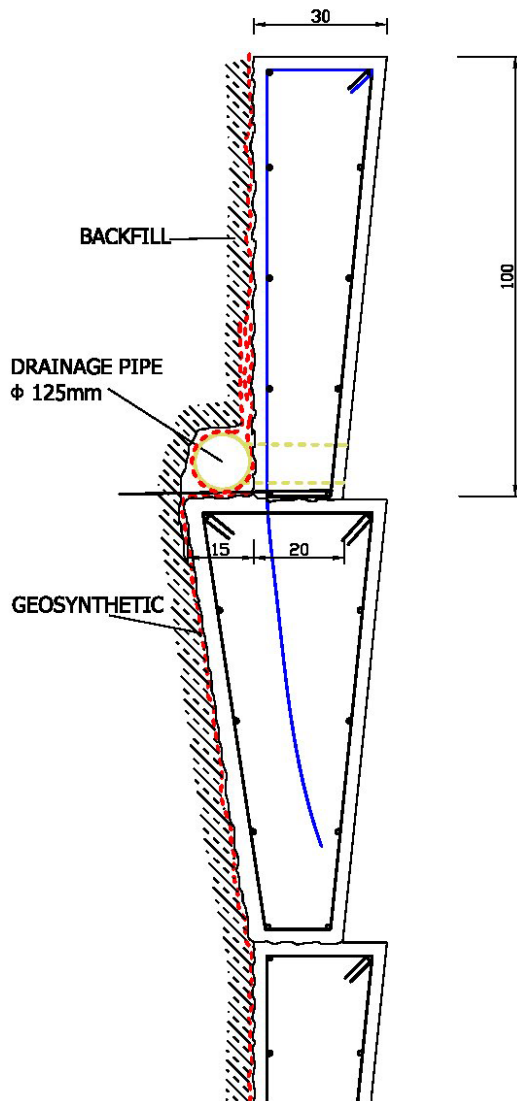
Fig. 19. Detail of the RC well.
